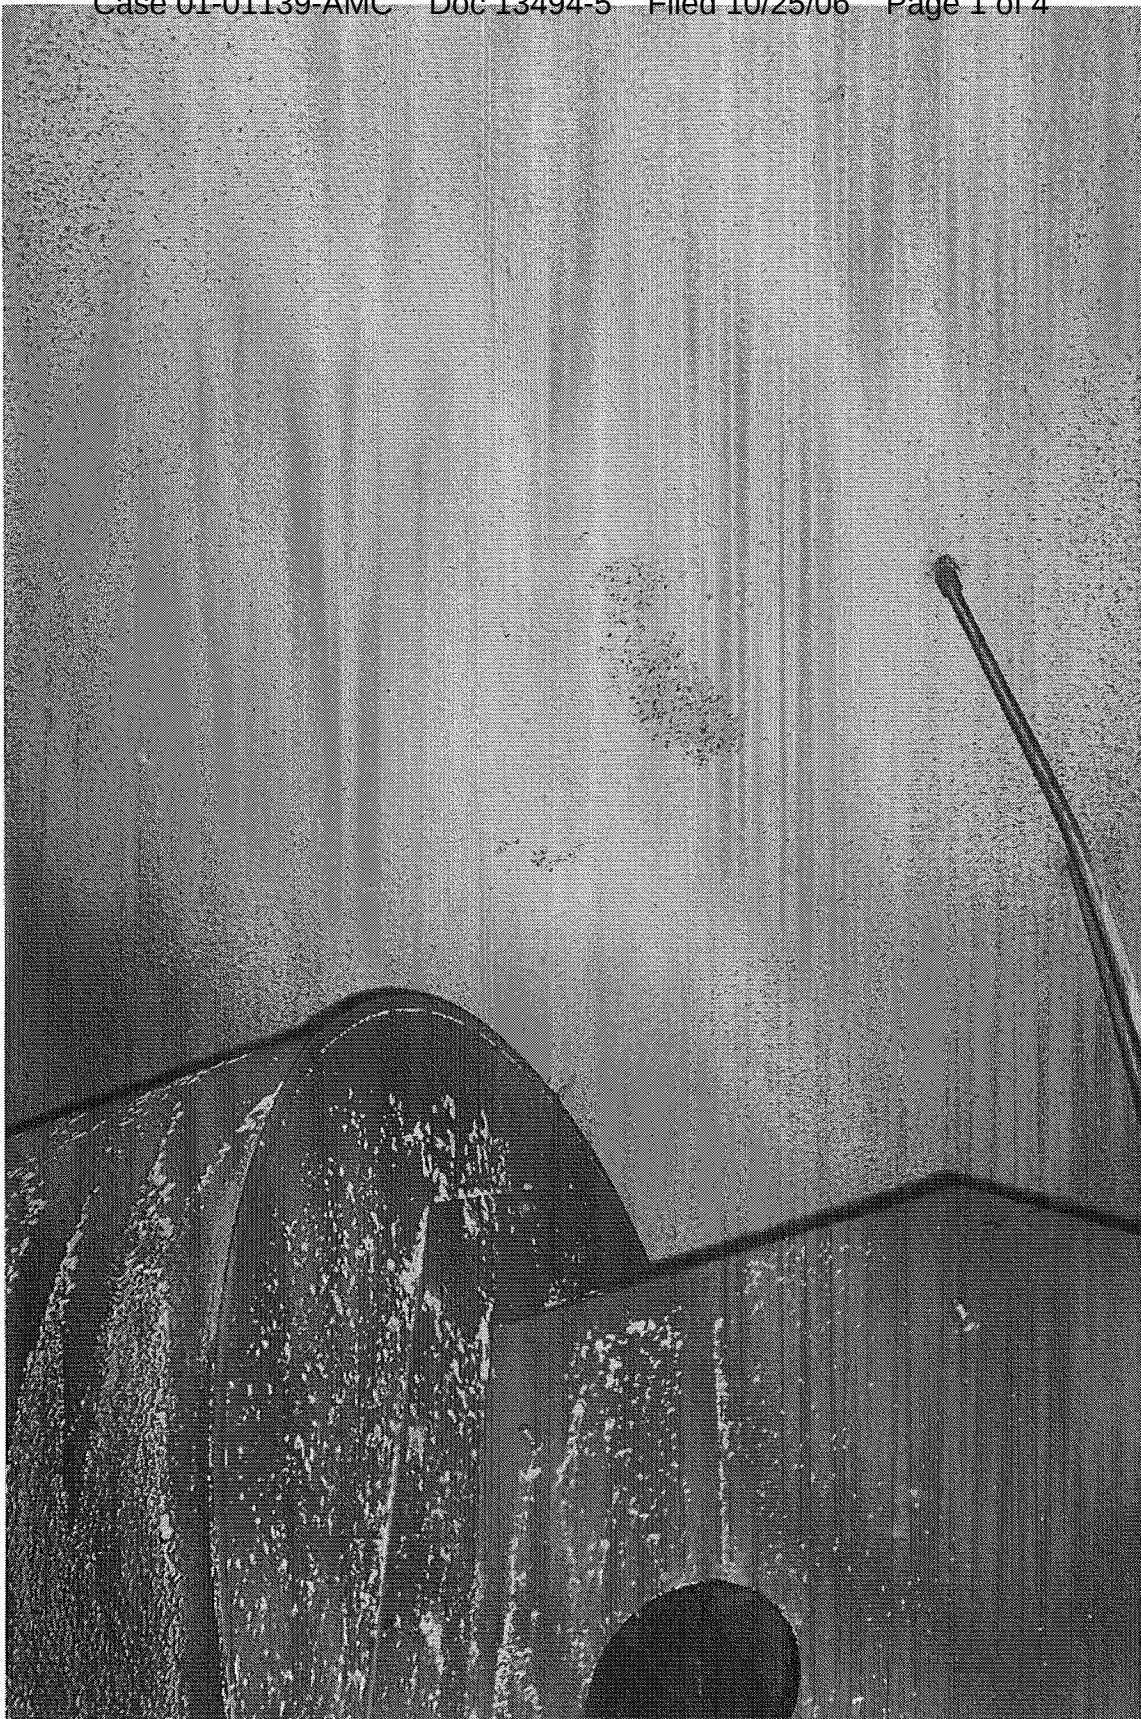
161. Boiler Room - Damaged acoustical plaster above fan motor

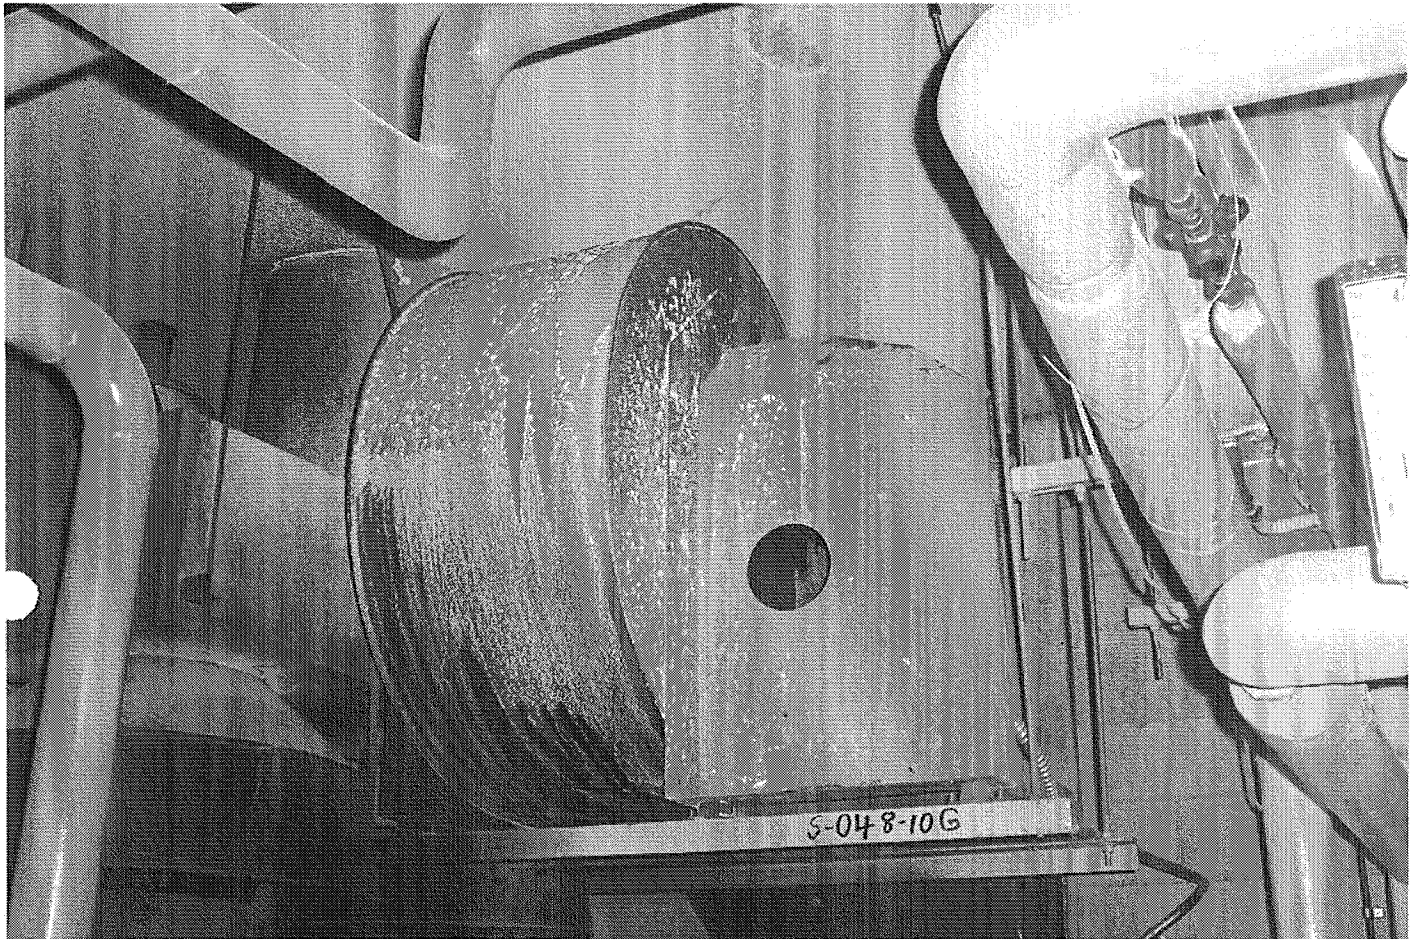
162. Boiler Room - Delaminated acoustical plaster dust and debris on mechanical equipment

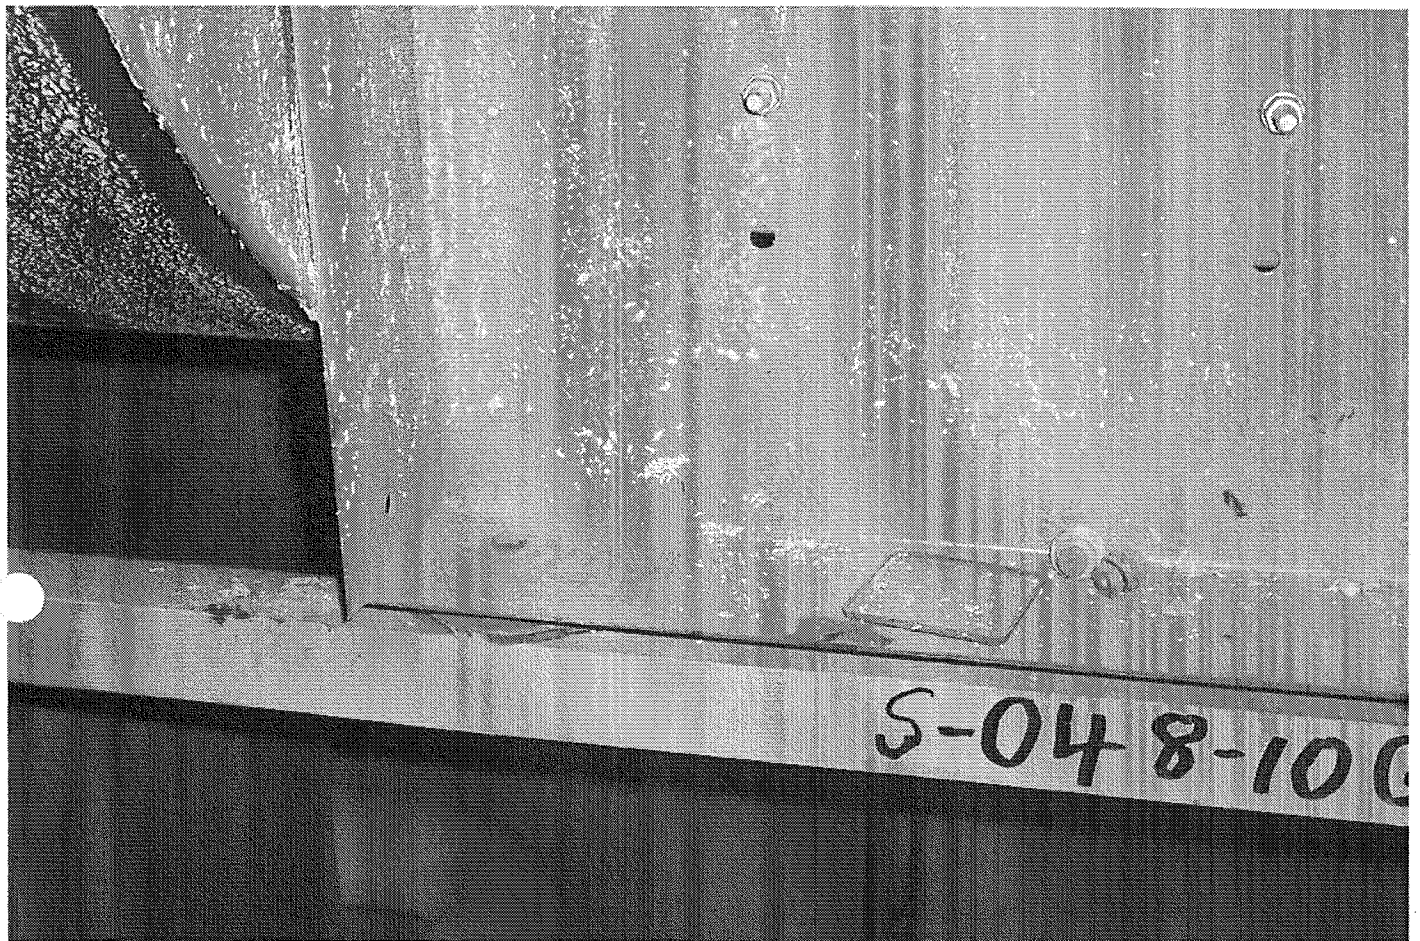
163. Boiler Room - Location of dust sample #1 (top of metal support brace)
